Exploring Mitigation Options to Reduce Vehicle-caused Mortality for the Oregon Silverspot Butterfly, *Speyeria zerene hippolyta*, along Highway 101 at the Siuslaw National Forest

Exploring mitigation options to reduce vehicle-caused
mortality for the Oregon Silverspot Butterfly,
Speyeria zerene hippolyta, along Highway 101 at the
Siuslaw National Forest

Prepared by: Sara B. Zielin, Master of
Environmental Management Student,
Portland State University

May 2010

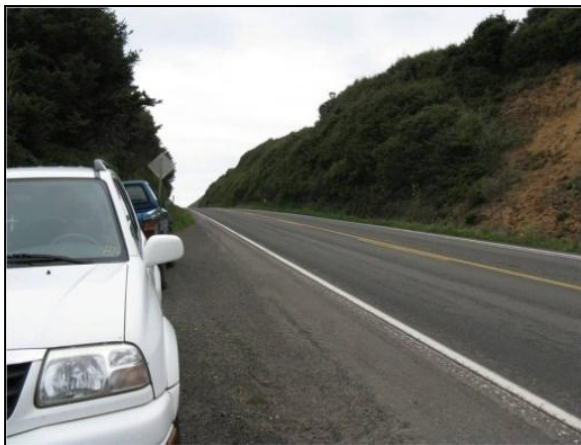
Figure 2. Road-cut area at Rock Creek – Big Creek Site, photo taken observing north from plot 8. Photo credit: Sara Zielin.

In some locations along Highway 101 the road surface is significantly lower than the adjacent meadows creating a walled corridor (road-cut) made of earth and vegetation reaching well over 5 m in height relative to the road surface (Figure 2). Plot 7 and the southern section of plot 8 were immediately south of the longest walled corridor at this site and north of the Big Creek Bridge. These same plots are also a location in which the road surface of Highway 101 slopes. The road begins to drop in elevation at the southerly end of the walled corridor (plot 8) and continues to slope downward toward the south at a moderate grade to the north-side of the Big Creek Bridge where the road levels again (plots 5 and 6) (Appendix 1).

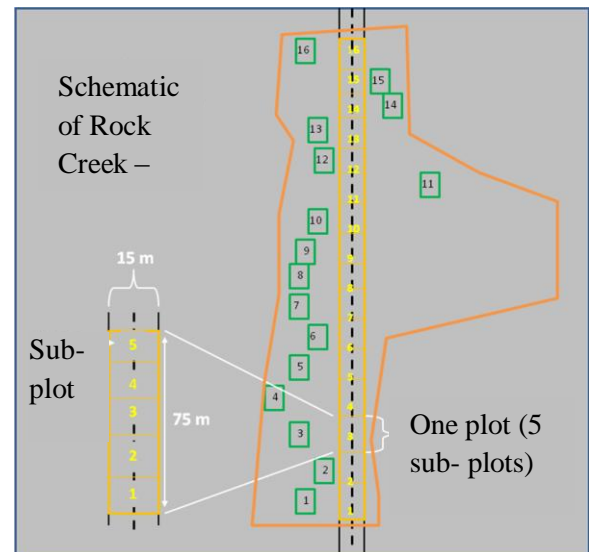
Figure 3. Schematic of study site. Road plots are in yellow, meadow plots are in green.

Within the study area, a 1.2 km section of Highway 101 was divided into 16 plots (1 plot = 75m x 8m), each of which were divided into 5 subplots (1 subplot = 15m x 8m) (Figure 3). The

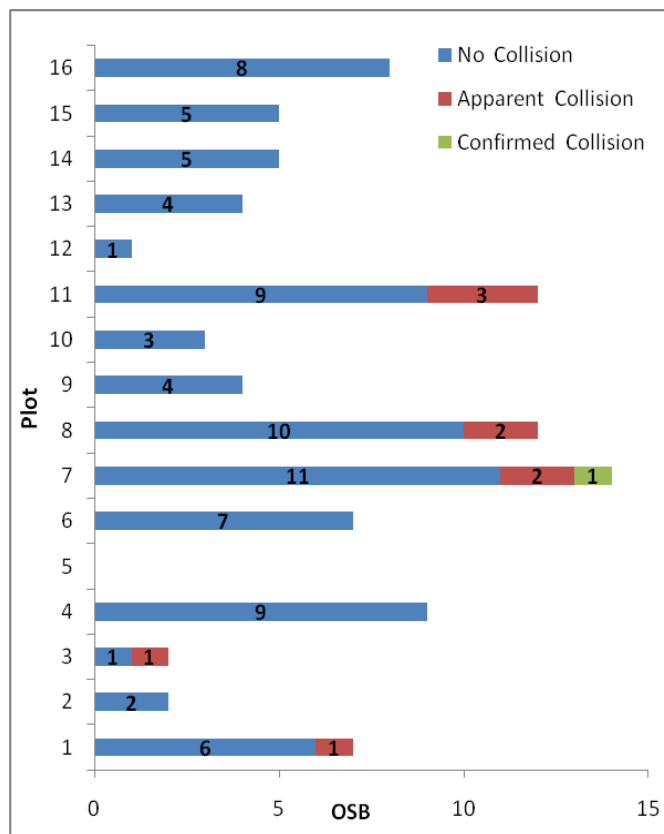
Figure 7. Vehicle and OSB interactions (no collision, apparent collision, confirmed collision) by plot for all accounts of detection either during surveys (scan or all occurrence) or opportunistic sightings. Across plots, 49 observations were from Instantaneous scan sampling, 24 were from all-occurrence surveys, and 22 were from opportunistic sampling.

There was one confirmed account of an OSB-vehicle collision: it occurred on August 19th at 11:02 am in plot 7 (subplot 34) (Figure 7). The road-killed OSB, which was sexed as a female, entered the road from the west and crossed both lanes of Highway 101 to the east-side of the road, flew north, then when it attempted to cross back to the west it collided with a southbound

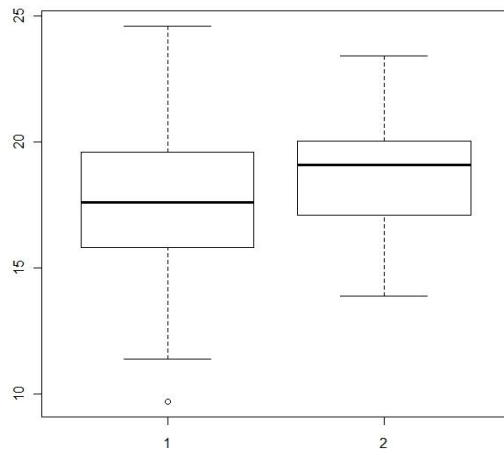
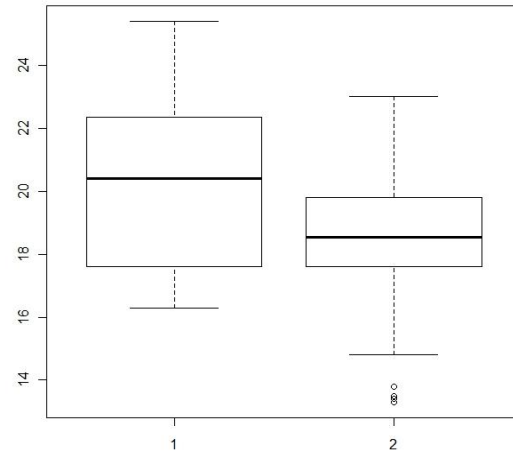
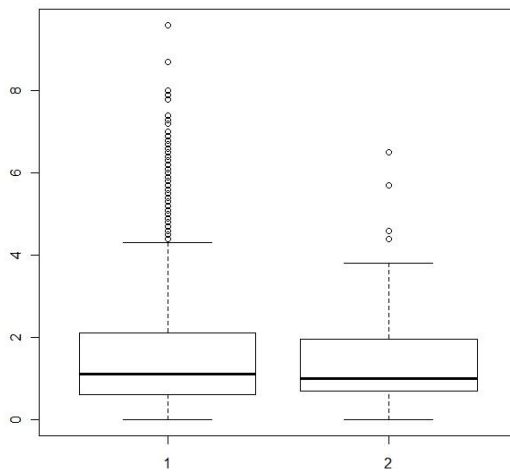
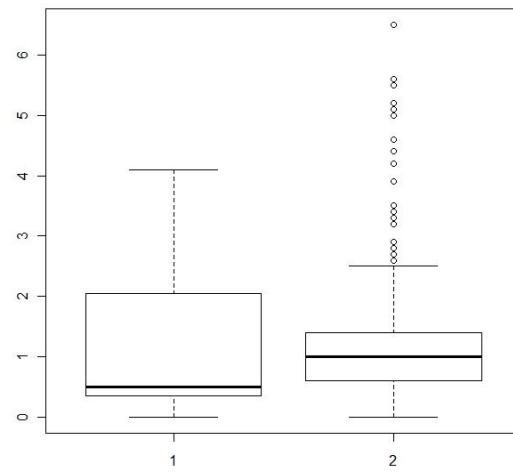
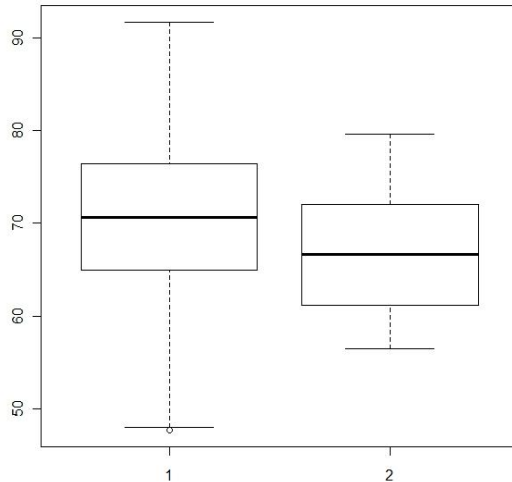
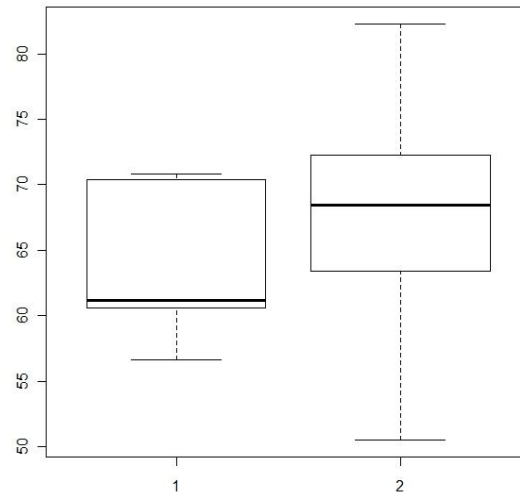
Figure 8a-f. Box plots of temperature (°C), wind (m/s), and humidity (%) with no OSB presence (1) vs. OSB presence (2) for the road and meadow (a) temperature in the road, b) temperature in the meadow, c) wind speed in the road, d) wind speed in the meadow, e) humidity in the road, and f) humidity in the meadow).

No OSBs were detected in the road below 13.9°C (57°F; Figures 8a-f). Also, no OSBs were detected below 56.5 % relative humidity or above 79.6 % in the road. Lastly, no OSBs were observed at wind speeds above 7.5 m/s (16.8 mph).

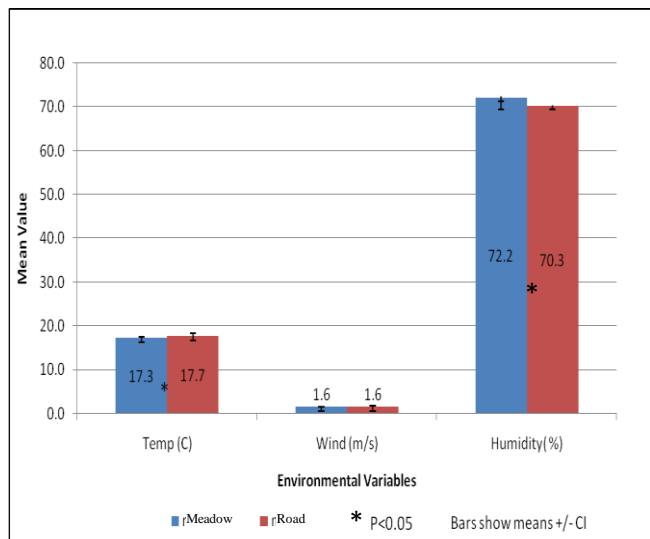
Figure 9. Mean values of environmental variables in the road and meadow (bars show +/- 95% C.I.; n=3200).

None of the environmental variables were significantly different in the road vs. meadow. (humidity: $\chi^2=2.2$, df=1, $p=0.137$; wind(ln): $\chi^2=0.07$, df 1, $P=0.793$; temp: $\chi^2=2.64$, df 1, $P=0.104$) there was much more variation across plots (humidity: $\chi^2=54.57$, df 30, $p = 0.004$; wind(ln): $\chi^2=45.48$, df 30, $p =$

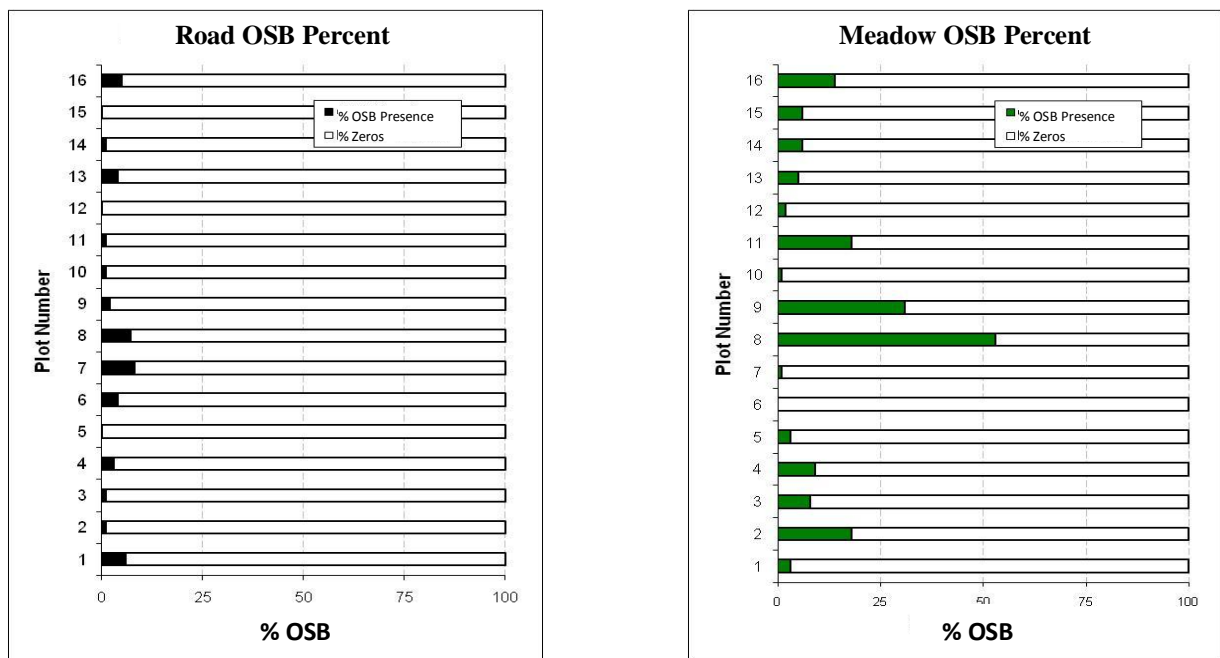
Figure 10. Percent OSB presence over road (*left*) and meadow (*right*) showing number of zeros (plots with no OSBs) by plot. Plot number 1 is at the south end of the site while plot number 16 is the farthest north.

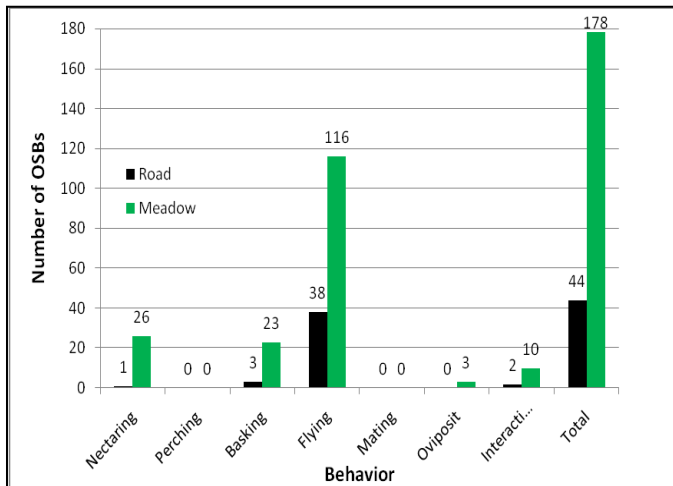
Figure 11. Total number of OSBs by behavior type in the road vs. meadow

There were only four behaviors observed in the road “nectaring”, “basking”, “flying” and “interactive” (Figure 11). The predominant behavior in both the road and meadow was “flying,” accounting for 86.4% of observations in the road and 65% of those in the meadow. OSBs do not seem to be attracted to the road for

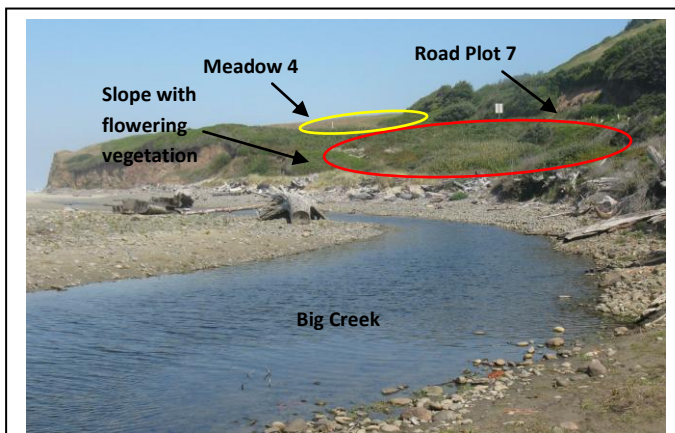
Figure 13. Photo of flowering vegetation adjacent to road plot 7 and south of meadow area 4. Photo credit: Sara Zielin.

The area west of the road plot 7 has many flowering plants (including *Rubus* sp.), but is not considered meadow and is more of a sloping transitional zone from meadow area 4 to Big Creek (Figure 13). This area, especially on windy days, seems to serve as shelter from the wind and OSBs were observed accumulating just south of the meadow area 4. Presumably, OSBs were taking shelter at this location when winds were very high in the more exposed meadow area (Figure 14). Indeed, OSBs may have been pushed there by northwest winds (Appendix 7). Meadow area 4 was also the location where the highest densities of OSBs (over 130 individuals/ha) were calculated during the 2009 OSB census surveys (Appendix 8 and 9) (Patterson 2009).

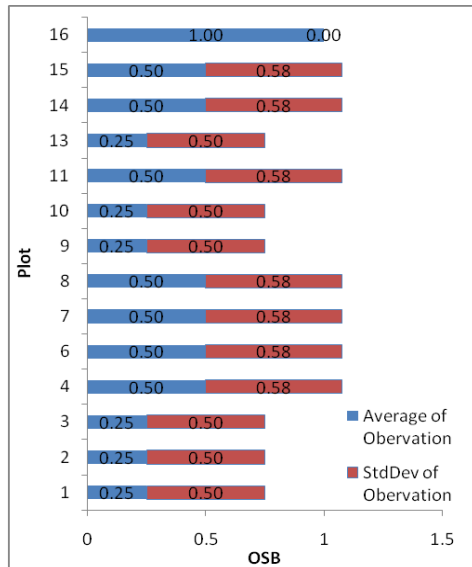
Figure 15. Mean OSB presence in road plots across days observed for all

24 OSBs were detected from the all-occurrence surveys (64 survey periods). These were observed in all road plots except plot 5 (Figure 15), which was beyond the Big Creek Bridge. The mean temperature and wind speed were slightly higher than those reported for the road scan surveys (Figure 16).

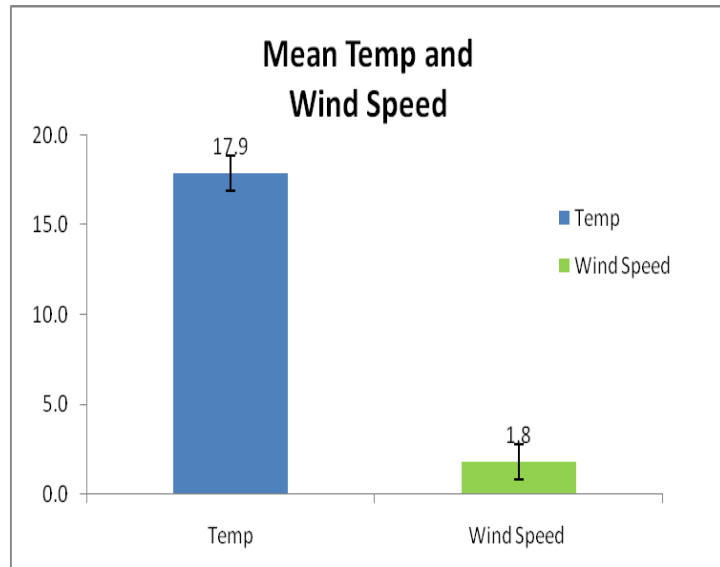
Figure 16. Mean temperature and wind speed for all occurrence surveys (+/- SD)

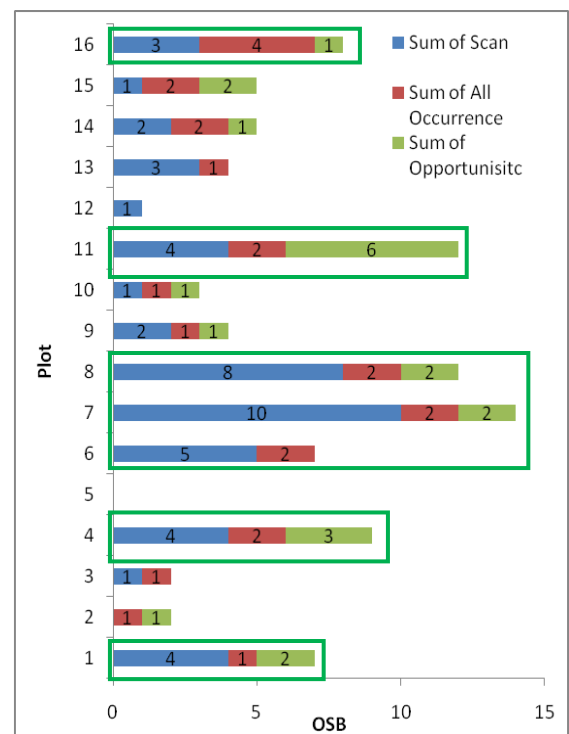
Figure 17. Number of OSBs by road plot for all accounts of detection either during surveys (scan (49) or all occurrence(24)) or opportunistic sightings (N=22) and the five main OSB crossing areas.

Five main locations of OSB road crossing, encompassing 7/16 plots (43.8%), which accounted for 72.6% (69/95) of the crossings, are apparent within the project area, excluding the opportunistic sightings (22 instances), the same five areas were prominent and accounted for 72.6% (53/73) of the 73 crossings (Figure 17). OSB height of flight among all the road plots ranged from 0.5 m – 4.5 m (relative to the road surface) and did not vary greatly ($1.6 \text{ m} \pm 0.8$, mean \pm SD). It

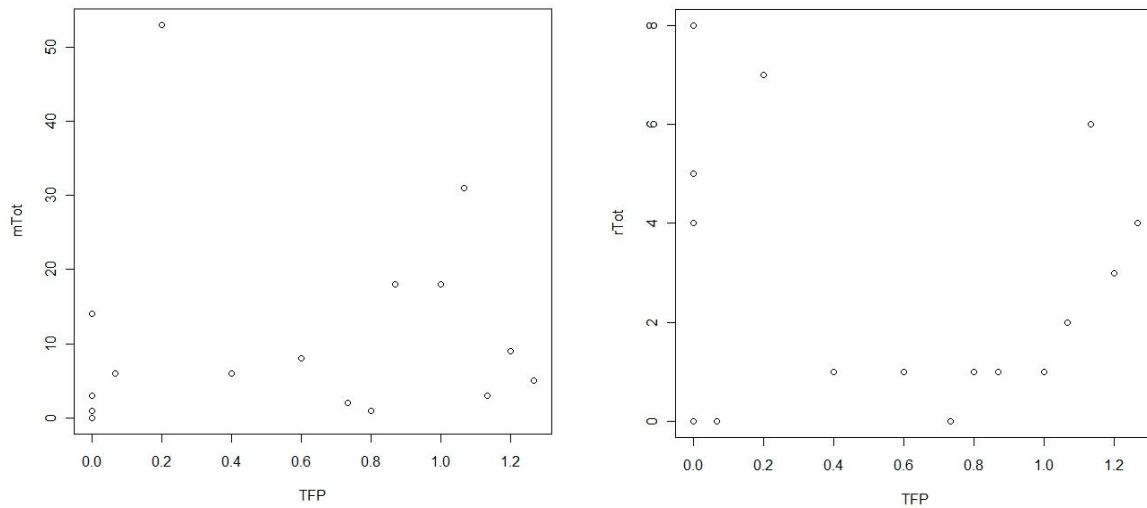
Figure 18. Scatterplots of OSBs detected in the meadow vs. flowering plants in the meadow (left) and OSBs detected in the road vs. flowering plants in the meadow (right)

We counted 5,601 flowering plants in the meadow ($n = 80$ subplots); subplots averaged 1.8 ± 2.59 (SD) flowering plants. Scatterplots revealed there was no strong linear relationship between the number of flowering plants in the meadow plots and the number of butterflies in those meadow plots or in the matched road plots (Figure 18).

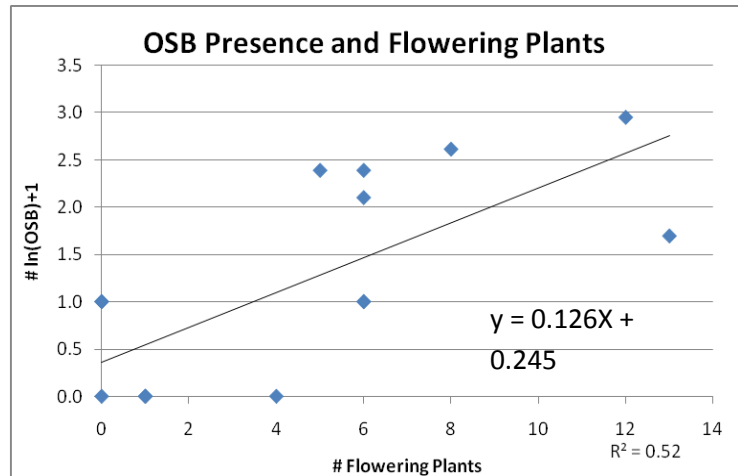
Figure 19. Linear regression of OSB presence vs. flowering plants in the road

More OSBs were found in subplots that had more flowering plants (Figure 19; linear regression: $r^2 = 0.51$, $t = 3.71$, $n = 15$, $F_{1,13} = 13.76$, $p = 0.003$, $y = 0.126X + 0.245$). Importantly, one OSB was observed performing “nectaring” behavior in the road; this occurred on the west-side of plot 7 where a large flowering plant was overhanging the guardrail into the road.

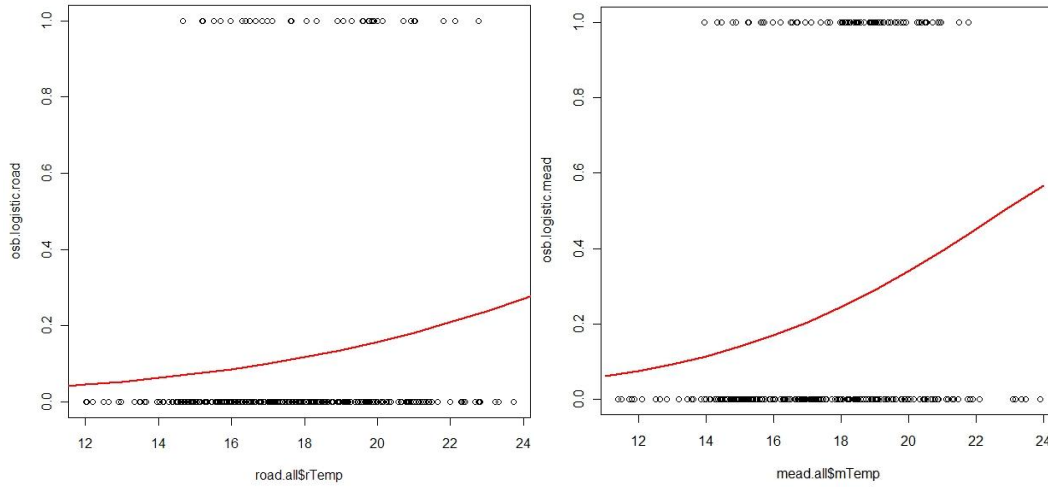
Figure 20. Logistic regression of OSB presence only for behaviors that can be performed in the road (i.e. “flying”, “basking”, and “nectaring”) and temperature (°C) in the road (*left*) and in the meadow (*right*). (Dataset reduced to 320 groups).

Both temperature and humidity were significantly related with OSB presence in both the road and the meadow. More OSBs were sighted at warmer temperatures (Figure 20; Logistic regression: positive relationship; road: $z = 2.349$, $df = 318$, $p = 0.0188$, and meadow: $z = 4.711$, $df = 319$, $p = 2.47 \times 10^{-6}$). The critical temperature determined for prediction of OSB presence was $\sim 19^\circ\text{C}$ (66°F) and no OSBs were detected below 13.9°C (57°F). Temperature when OSBs were sighted averaged $19.1^\circ\text{C} \pm 2.1$. Fewer OSBs were found at higher humidity (Figure 21; negative relationship; road: $z = -2.68$, $df = 318$, $p = 0.0073$, and meadow: $z = -4.390$, $df = 319$, $p = 1.13 \times 10^{-5}$). The critical relative humidity value was $\sim 65.0\%$, where OSB presence becomes less likely above this value. Also, no OSBs were detected below 56.5% relative humidity or above 79.6% in the road (Table 5). Mean humidity during periods when OSBs were present was $65.5\% \pm 15.0$. Wind was not significantly correlated with OSB presence in this dataset (road: $z = -0.677$, $df = 318$, $p = 0.498$, and meadow: $z = -1.835$, $df = 319$, $p = 0.758$) but it should be

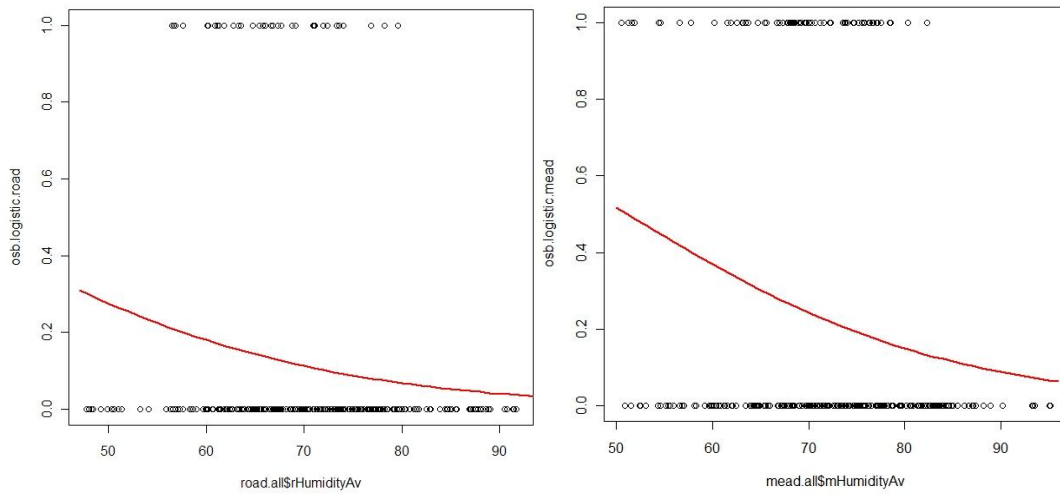
Figure 21. Logistic regression of OSB presence only for behaviors that can be performed in the road (i.e. “flying”, “basking”, and “nectaring”) and relative humidity (%) in the road (*left*) and in the meadow (*right*). (Dataset reduced to 320 groups).
